Manhole Inspection Summary

Manhole # S25G__036MH

Insp Date: **8/10/09 10:10 AM**

Location Address: **1310 BALTIMORE ST**

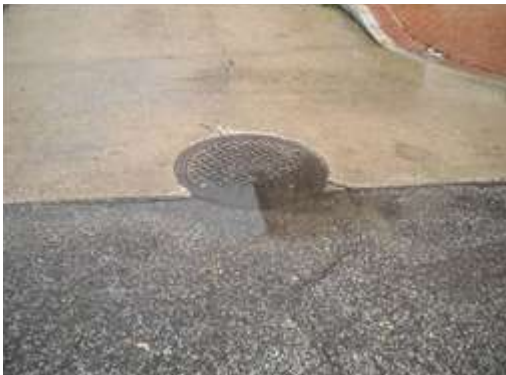
Subject To Ponding: **Ponding**

ADDED PHOTO OF OBSERVED PONDING AND UPDATED RECORD TO REFLECT THAT. ALL PIPES ARE VCP CLAY PIPE. 8/10/09

Ponding

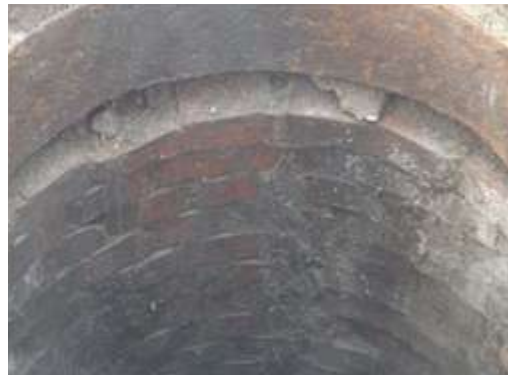
Defect 2

Condition: ☐ Sound ☐ Cracked ☐ Root Intrusion ☐ Loose Brick ☒ **Deteriorated**

deteriorated chimney

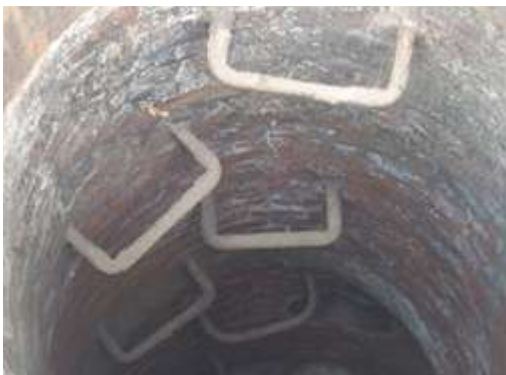
Defect 1

Count: **6** Missing: **0** ☒ **Corroded**

corroded steps

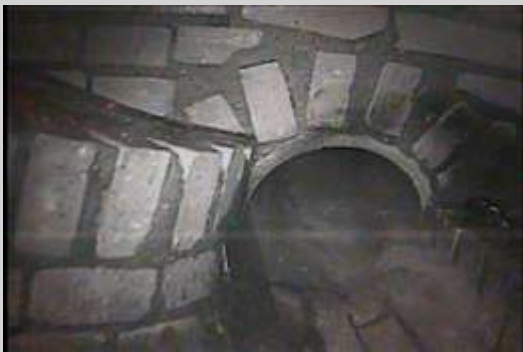
12 O'Clock Outflow

Pipe Height: **10.8** (in.) Rod and Bar (Angled)
Pipe Material: **Clay** ☐ Pipe Lined
Invert Depth: **11.38** (ft.) Flow Characteristics: **Slow**
Deposits: ☒ None ☐ Mud ☐ Sludge ☐ Debris ☐ Grease
Silt Depth: (in.) Deposits Extent:
Infiltration: **None** Pipe Seal Cond: **Sound**

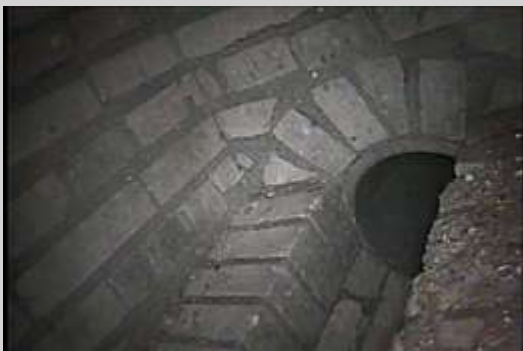
6 O'Clock Inflow

Pipe Height: **7.2** (in.) Rod and Bar (Angled)
Pipe Material: **Clay** ☐ Pipe Lined
Invert Depth: **11.12** (ft.) Flow Characteristics: **Slow**
Deposits: ☒ None ☐ Mud ☐ Sludge ☐ Debris ☐ Grease
Silt Depth: (in.) Deposits Extent:
Infiltration: **None** Pipe Seal Cond: **Sound**

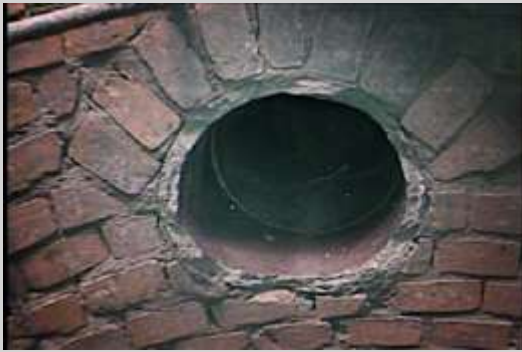
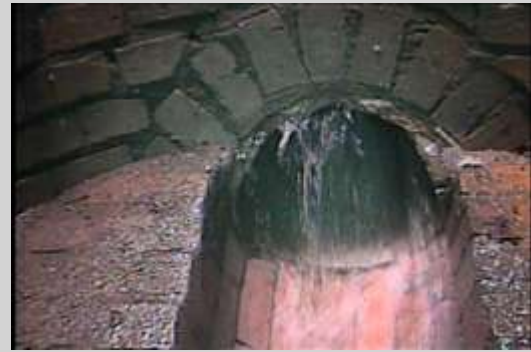
9 O'Clock Inflow

Pipe Height: **9.6** (in.) Rod and Bar (Angled)

Invert Depth: **7.65** (ft.) Flow Characteristics: **Fast**

Infiltration: **None** Pipe Seal Cond: **Sound**

Drop: **Outside** Rod and Bar

Drop Condition: **Open**
